DEPARTMENT OF TRANSPORTATION**DIVISION OF ENGINEERING SERVICES**

Office of Structural Materials

Contract #: 04-0120F4Cty: SF/ALA Rte: 80 PM: 13.2/13.9File #: 69.28**WELDING INSPECTION REPORT****Resident Engineer:** Pursell, Gary**Address:** 333 Burma Road**City:** Oakland, CA 94607**Report No:** WIR-003681**Date Inspected:** 20-Aug-2008**Project Name:** SAS Superstructure**OSM Arrival Time:** 1430**Prime Contractor:** American Bridge/Fluor Enterprises, a JV**OSM Departure Time:** 2230**Contractor:** Zhenhua Port Machinery Company, Ltd (ZPMC), Changxing Island **Location:** Shanghai, China**CWI Name:** See below**CWI Present:** Yes No**Inspected CWI report:** Yes No N/A**Rod Oven in Use:** Yes No N/A**Electrode to specification:** Yes No N/A**Weld Procedures Followed:** Yes No N/A**Qualified Welders:** Yes No N/A**Verified Joint Fit-up:** Yes No N/A**Approved Drawings:** Yes No N/A**Approved WPS:** Yes No N/A**Delayed / Cancelled:** Yes No N/A**Bridge No:** 34-0006**Component:** OBG Fabrication**Summary of Items Observed:**

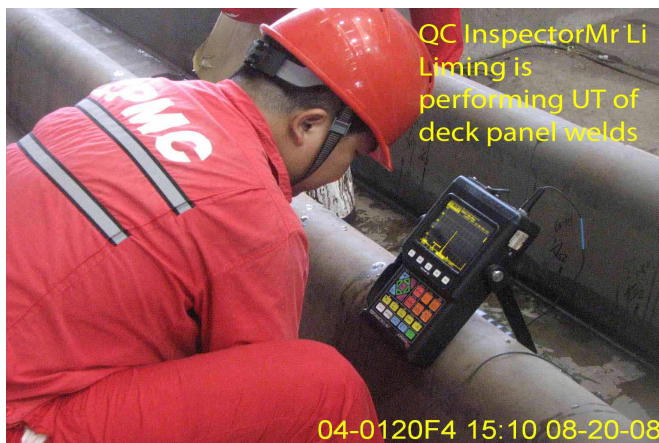
ZPMC presented QA with a "Notification of Witness Inspection" document #882 which states that deck plate closed rib welds on DP594-001, DP606-001 and DP546-001 are to be ultrasonically inspected today for the purpose of determining the amount of weld penetration today at 1430 hours. Around 1500 hours the QA Inspector observed ZPMC ultrasonic Inspectors Mr. Li Li Ming, Mr. Ma Ji Long and Mr. Tang Xing Shan performing ultrasonic depth of penetration inspections of portions of deck panel DP594-001 welds 1 through 10, DP546-002 welds 1 through 8 and DP606-001 welds 1 through 6. The QA Inspector observed the ultrasonic Inspectors are using a black felt pen to mark depth of penetration measurements where they had measured less than complete weld penetration. The QA Inspector observed that ZPMC ultrasonic Inspectors scanning deck panel DP352-002 instead of deck panel DP352-001 which was listed on the "Notification of Witness Inspection" document #882. The QA Inspector asked QC representative Mr. Shen Xuejun if the "Notification of Witness Inspection" document

is correct or if the ultrasonic Inspectors are on the wrong location. Mr. Shen Xuejun said the ZPMC ultrasonic inspectors are inspecting the correct deck plate (DP352-002), and that the "Notification of Witness Inspection" document #882 lists the wrong number. See the photograph below for additional information.
